Manhole Inspection Summary

Manhole # S33E__049MH

Insp Date: **8/27/08 10:40 AM**

Location Address: **228 w lexington st**

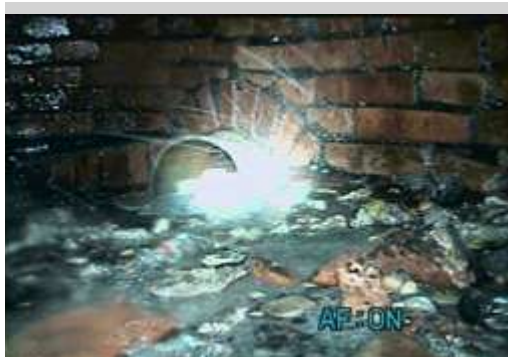
Defect 4

Condition: ☐ Sound ☐ Cracked ☐ Root Intrusion ☐ Deteriorated ☐ Leaks ☒ **Debris**

Channel Debris

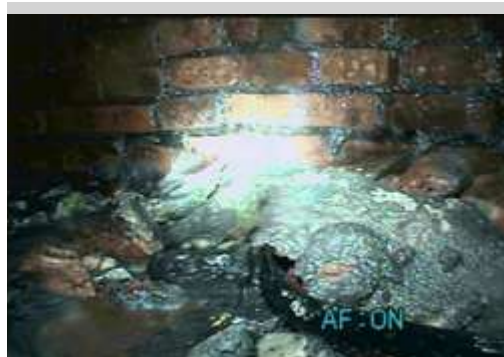
Defect 3

Condition: ☐ Sound ☐ Cracked ☐ Root Intrusion ☐ Deteriorated ☐ Leaks ☒ **Debris**

bench debris

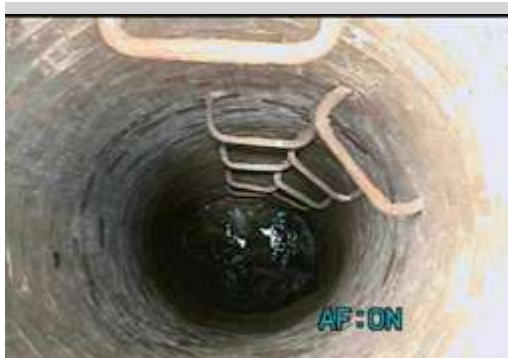
Defect 2

Count: **12** Missing: **0** ☒ **Corroded**

steps

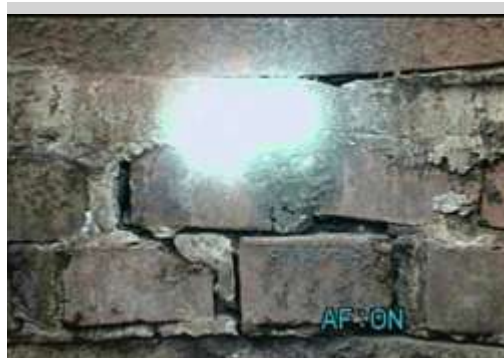
Defect 1

Condition: ☐ Sound ☒ **Cracked** ☐ Root Intrusion ☐ Loose Brick ☒ **Deteriorated**

chimney cracked, deteriorated, frame adj
